CORROSION BEHAVIORS OF MAGNESIUM FILM COATED WITH BIOCOMPATIBLE MATERIALS UNDER PSEUDO-BIOLOGICAL ENVIRONMENT

S. Manzaki¹, T. Kojima¹, and M. Notomi¹

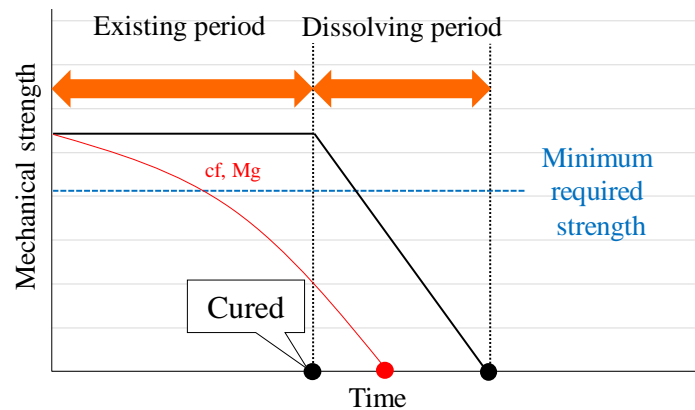
Figure 1: Mechanical strength of pure Mg and ideal biodegradable materials at corrosion times.

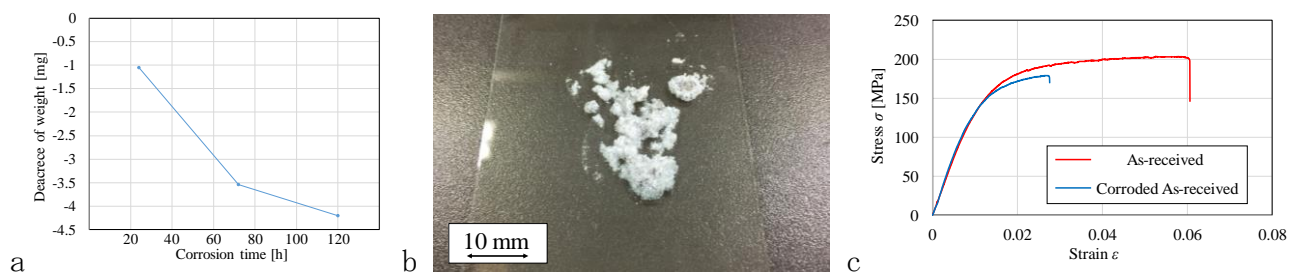
In Fig. 3 It was shown that the decrease of the weight of As-received and Mg/Ti (Fig.3(a)), an image of corroded Mg/Ti (Fig.3(b)), and the stress-strain curve of As-received before and after the corrosion test (Fig.3(c)). The decrease of the weight of 72h was 2.49 mg more than that of 24h. The decreased weight with 120h was 0.66 mg and less than that of 72h. We confirmed the specimen had Na on its surface according to XRD analysis, which was included in the solution, i.e., Saline. It seemed that component of the solution was coated during the corrosion progress. This Na might suppress the loss of the weight even though the corrosion. On the other hand, Mg/Ti completely dissolved after 24h due to the corrosion (Fig.3(b)). The corrosion potential between Mg and Ti is 1.6V [4] and that caused the dissolution of Mg and Ti. In the mechanical test, Fig.3(c) indicates that the stress and strain of As-received decreased 21.5 MPa and 0.311 ϵ with corrosion, respectively.

Figure 3: (a) The decrease of weight of As-received,(b) Corroded Mg/Ti, (c) The stress-strain curve of As-received.

Even though the mechanical strength decreased with corrosion, the corrosion products, Na suppressed the decrease of the weight of the specimen under the pseudo-biological environment. This effect might be available for controlling the times of Existing and Dissolving period.
